STUDY ON INFRARED THERMOGRAPHIC INSPECTION OF
DE-BONDED LAYER OF AIRPORT FLEXIBLE PAVEMENT

PRESENTED FOR THE
2007 FAA WORLDWIDE AIRPORT TECHNOLOGY TRANSFER CONFERENCE
Atlantic City, New Jersey, USA

April 2007

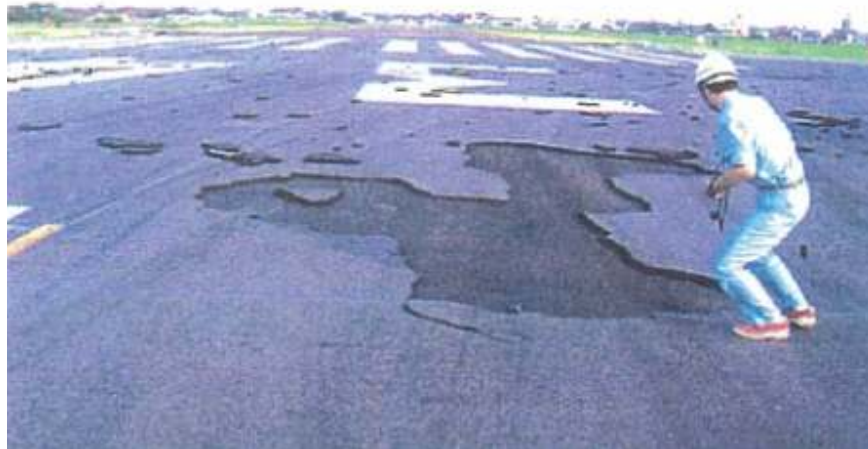
In July 2000, slippage failure occurred at the end of the runway of Nagoya Airport in Japan due to loss of bond between the surface and binder course as shown in Figure 1. The thickness of the surface course was 5 cm, the slippage area was 4 m wide and 8 m long, and the runway had to be closed for a time [1]. The surface course in this area had been constructed in 1999. The reason of this slippage was due to the top layer not properly bonded to the layer below and the large horizontal load of aircraft at takeoff.

Figure 1. Slippage failure Due to Loss of Bond at Nagoya Airport.

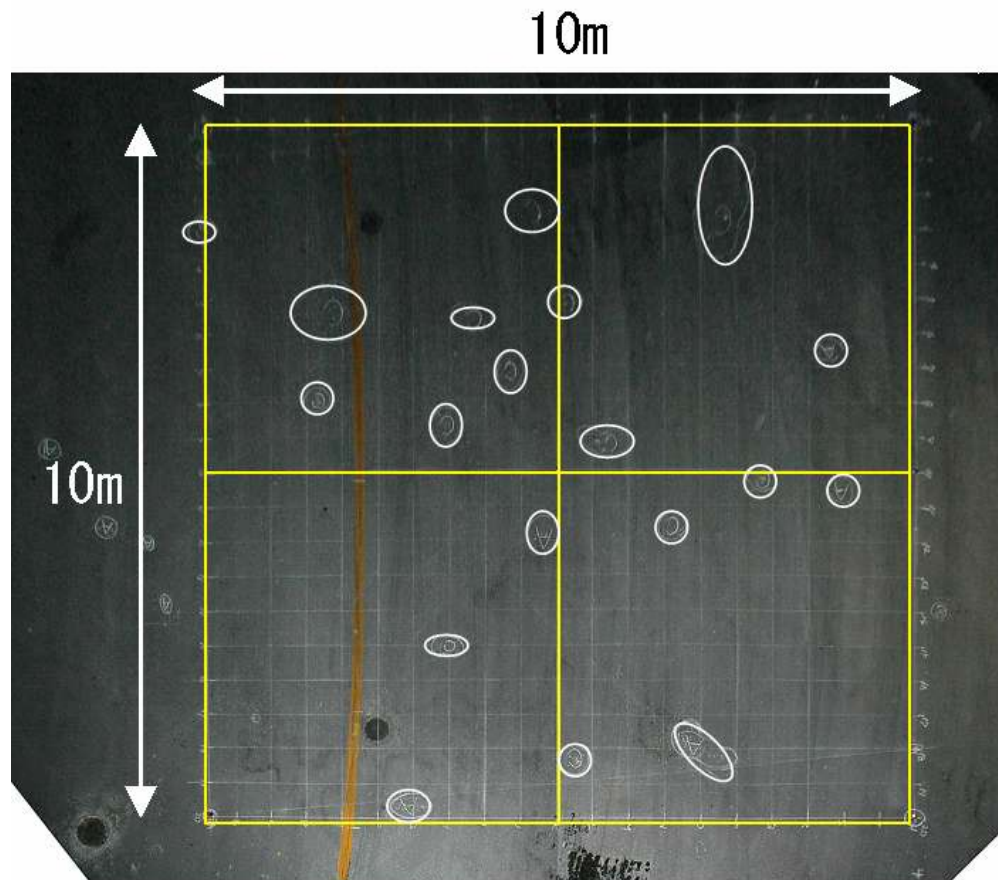
Figure 5 shows a visible image of the inspection area from a height of 10 m. Circular marks indicate de-bonded areas found by the impact acoustic method. Figure 6 shows an infrared image of the same inspection area. In Figure 6, the black areas were cooler than the white areas. Comparing these two images, the low-temperature areas generally match the de-bonded areas found by the impact acoustic method.

Figure 5. Visible Image of Inspection Area.

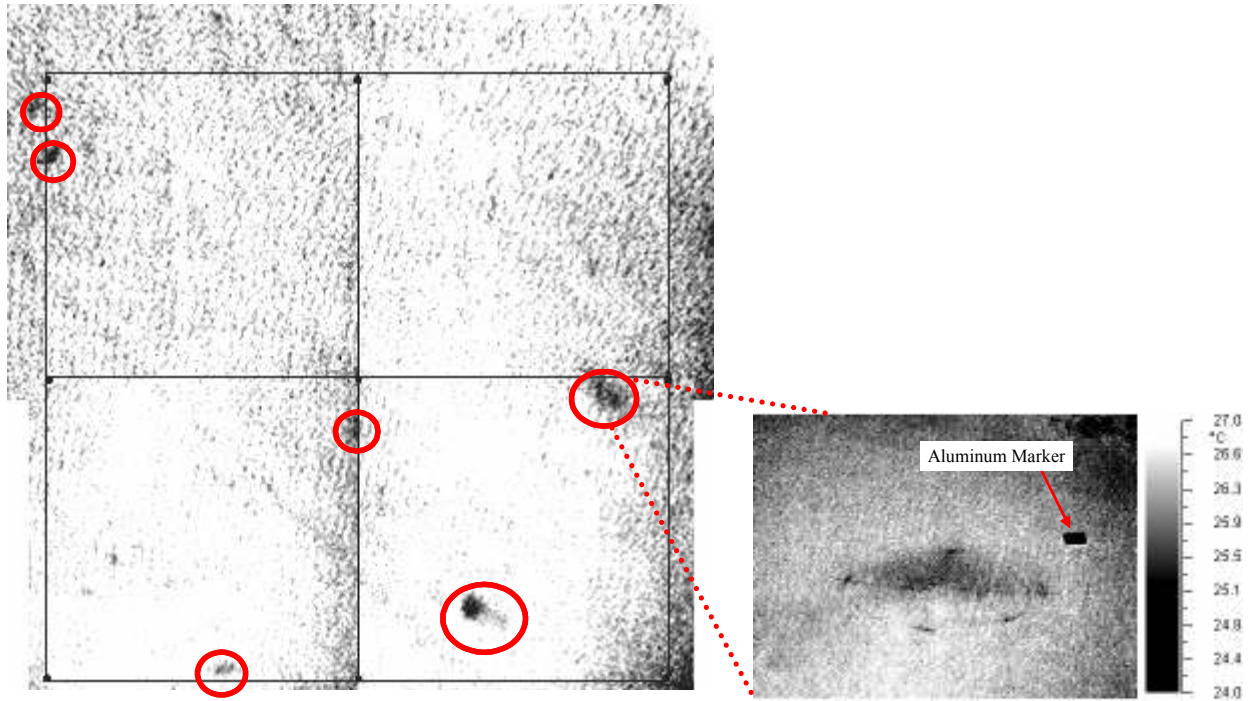
Figure 6. Infrared Image of Inspection Area (Black = Low Temperature).

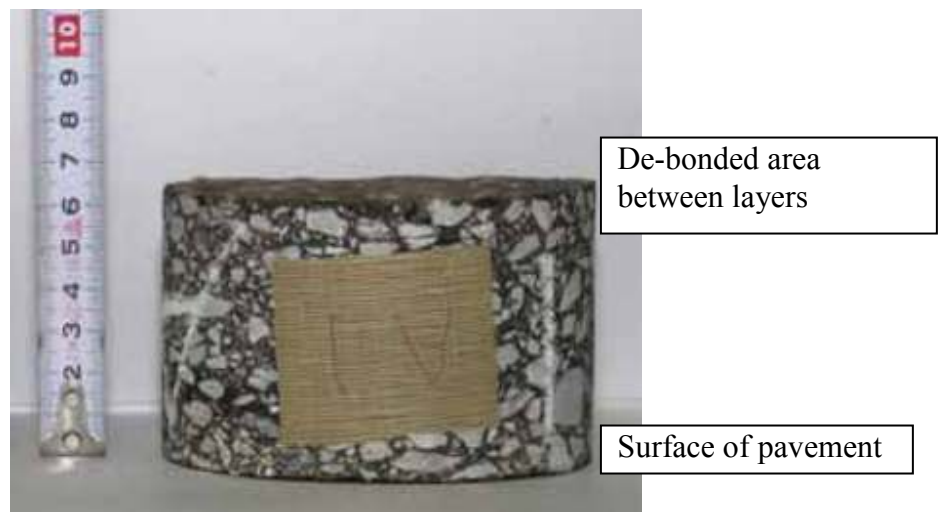
After taking infrared images of the inspection area, core boring was carried out at seven low-temperature areas to confirm the depth of de-bonding. As a result, we confirmed de-bonding at all seven areas at a depth of 40 – 70 mm as shown in Figure 7. Figure 8 shows the change of temperature measured on surface of both the de-bonded area (the depth of de-bonding is 50 mm) and its surrounding by using infrared thermography. These results clearly show that the surface temperature on the de-bonded area was lower than that of its surrounding from midnight to morning.

Figure 7. Core Sample Obtained at De-bonded Area.

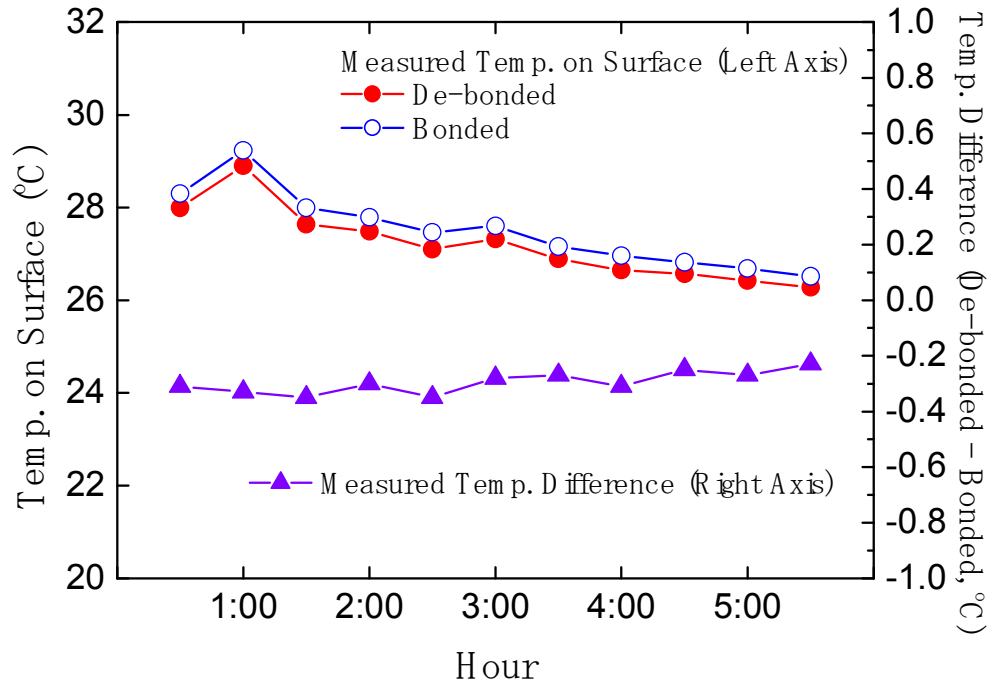
Figure 8. Variation of Temperature and Temperature Difference on Surface.

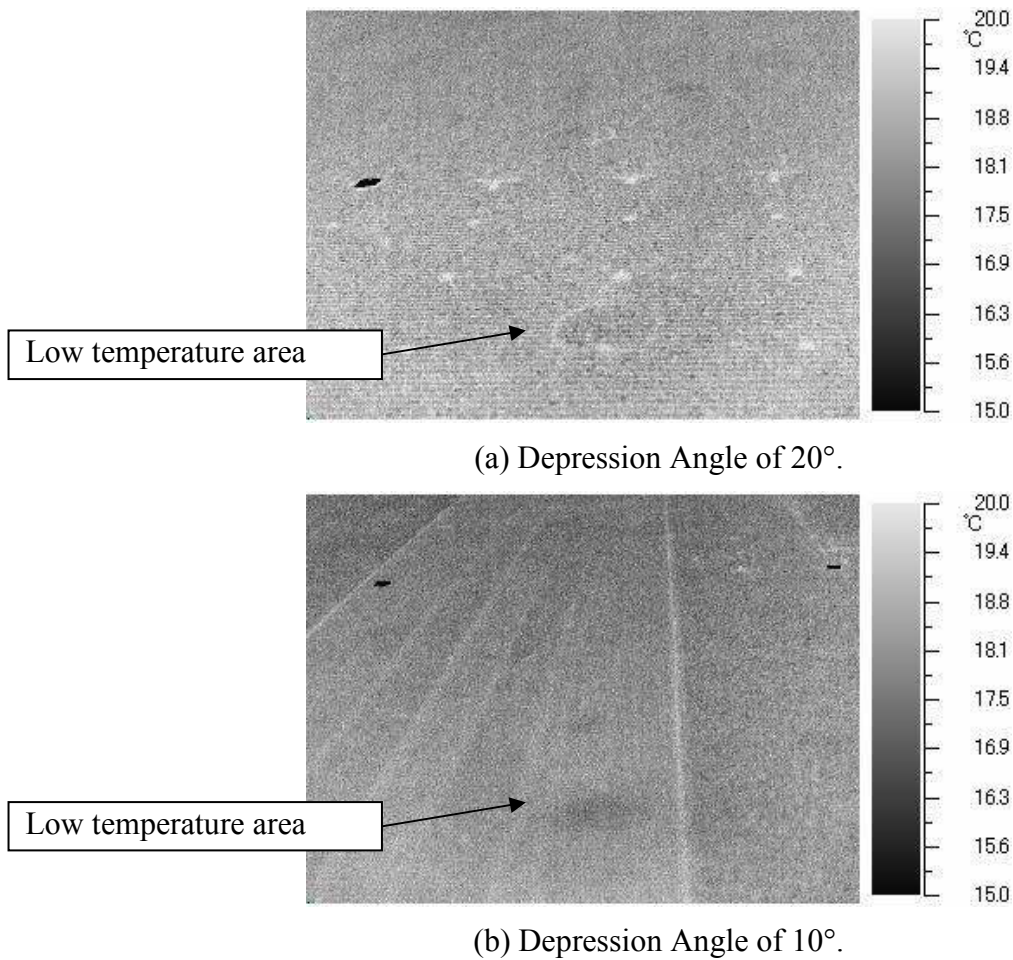
Figure 10 shows infrared images taken from the same height (about 3 m) and same range of temperature (15 - 20°C) but at different depression angle. It was easy to see the black (low-temperature) areas in infrared images at the depression angle of 10°, whereas the striped pattern due to grooves could be seen clearly and the black (low-temperature) areas could not be easily seen in infrared images at the depression angle of 20°. Thus, infrared images should be taken at a low depression angle to enable the inspector to identify the de-bonded areas in grooved runways and taxiways.

Figure 10. Infrared Images at Different Depression Angles.
